# Manhole Inspection Summary

Manhole # S19K1\_008MH

Insp Date: **5/1/08 10:49 AM**

**Location** Address: **3204 polar av**

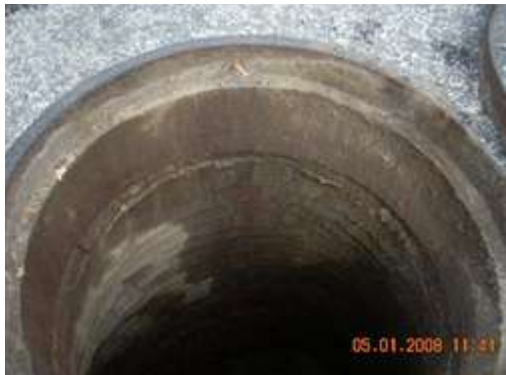
Defect 1

Infiltration: ☐ None ☒ **Joint** ☐ Cracks ☐ Mortar ☐ Roots ☐ Wall

inflow evidence @ corbel joint from sheeting

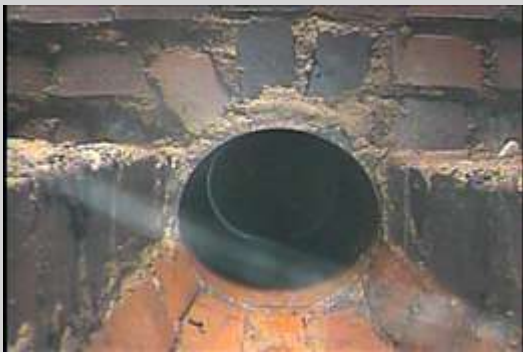
12 O'Clock Outflow

8 in. Circular Gravity Sewer  
Pipe Out @ 12 O'Clock

Pipe Height: **8.4** (in.) Rod and Bar (Angled)  
Pipe Material: **Clay** ☐ Pipe Lined  
Invert Depth: **7.80** (ft.) Flow Characteristics: **Slow**  
Deposits: ☒ None ☐ Mud ☐ Sludge ☐ Debris ☐ Grease  
Silt Depth: **0** (in.) Deposits Extent:  
Infiltration: **None** Pipe Seal Cond: **Sound**

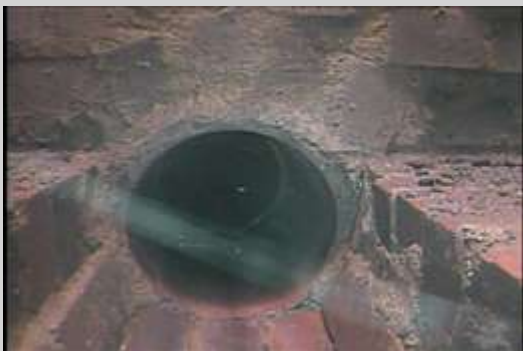
6 O'Clock Inflow

8 in. Circular Gravity Sewer  
Pipe In @ 6 O'Clock

Pipe Height: **8.4** (in.) Rod and Bar (Angled)  
Pipe Material: **Clay** ☐ Pipe Lined  
Invert Depth: **7.55** (ft.) Flow Characteristics: **Slow**  
Deposits: ☒ None ☐ Mud ☐ Sludge ☐ Debris ☐ Grease  
Silt Depth: **0** (in.) Deposits Extent:  
Infiltration: **None** Pipe Seal Cond: **Sound**
